# Manhole Inspection Summary

Manhole # S27G\_\_031MH

Insp Date: **9/4/07 7:45 AM**

**Location** Address: **902 FAYETTE ST**

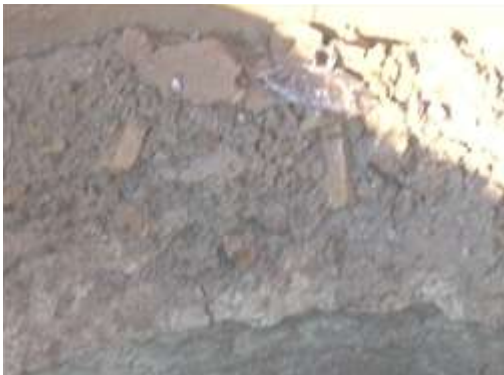
Defect 5

Condition: ☐ Sound ☐ Cracked ☐ Root Intrusion ☐ Loose Brick ☒ **Deteriorated**

DETERIORATION OF CORBEL

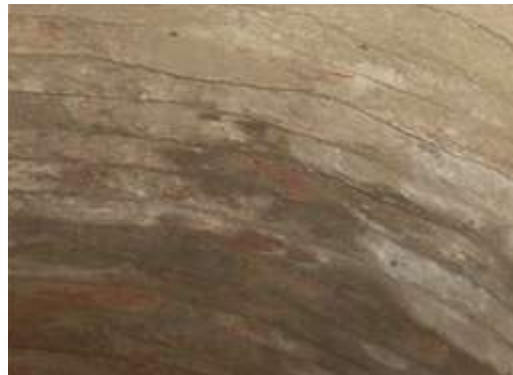
Defect 4

Infiltration: ☐ None ☐ Joint ☐ Cracks ☐ Mortar ☐ Roots ☒ **Wall**

CORBEL INFILTRATION

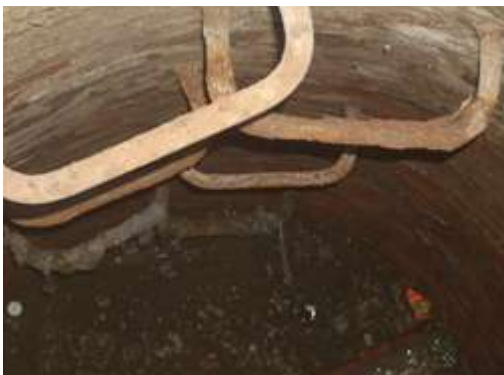
Defect 3

Count: **5** Missing: **1** ☒ **Corroded**

CORRODED STEPS

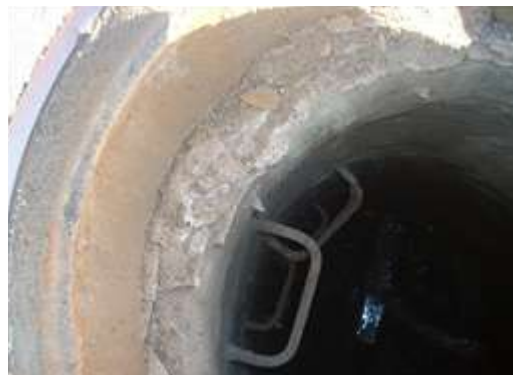
Defect 2

Offset: **5** (in.)

FRAME OFFSET

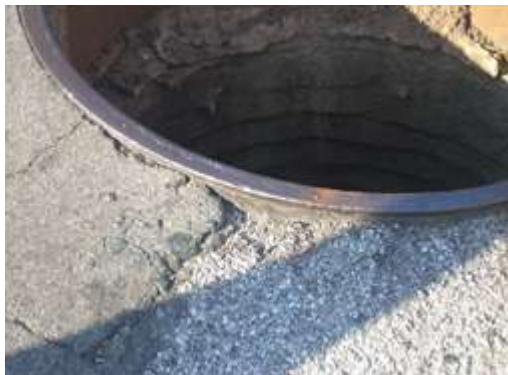
### Defect 1

Diameter: **24** (in.) Length: (in.) Dist A/B Grade: **1** (in.)

GRADE ADJ

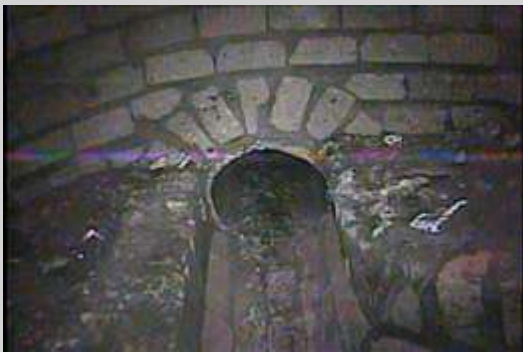
12 O'Clock Outflow

Pipe Height: **7.2** (in.) Rod and Bar (Angled)  
Pipe Material: **Clay** ☐ Pipe Lined  
Invert Depth: **10.66** (ft.) Flow Characteristics: **Slow**  
Deposits: ☐ None ☐ Mud ☒ **Sludge** ☐ Debris ☐ Grease  
Silt Depth: **1** (in.) Deposits Extent: **Light**  
Infiltration: **None** Pipe Seal Cond: **Sound**

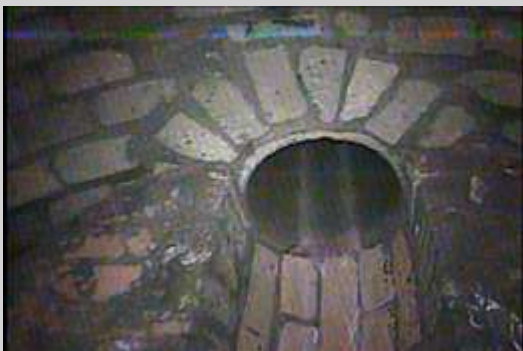
3 O'Clock Inflow

Pipe Height: **8.4** (in.) Rod and Bar (Angled)  
Pipe Material: **Clay** ☐ Pipe Lined  
Invert Depth: **10.09** (ft.) Flow Characteristics: **Slow**  
Deposits: ☒ None ☐ Mud ☐ Sludge ☐ Debris ☐ Grease  
Silt Depth: (in.) Deposits Extent:  
Infiltration: **None** Pipe Seal Cond: **Sound**

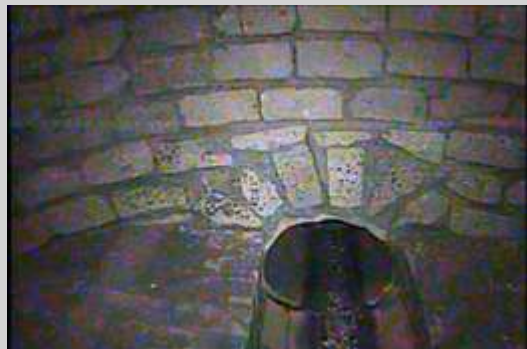
6 O'Clock Inflow

Pipe Height: **7.2** (in.) Rod and Bar (Angled)

Deposits: ☒ None ☐ Mud ☐ Sludge ☐ Debris ☐ Grease

Infiltration: **None** Pipe Seal Cond: **Sound**
